Official Accident Report Index Page

Report Number	NTSB/AAR-84/15
Access Number	PB84-910415
Report Title	Scandinavian Airlines System Flight 901 McDonnell Douglas CD-10-30 Norwegian Registry LN-RKB John F. Kennedy International Airport Jamaica, New York, February 28, 1984
Report Date	November 15, 1984
Organization Name	National Transportation Safety Board Bureau of Accident Investigation Washington, D.C. 20594
WUN	3894-A
Sponsor Name	NATIONAL TRANSPORTATION SAFETY BOARD Washington, D. C. 20594
Report Type	Aircraft Accident Report February 28, 1984
Distribution Status	This document is available to the public through the National Technical Information Service Springfield, Virginia 22161
Report Class	UNCLASSIFIED
Pg Class	UNCLASSIFIED
Pages	85
Keywords	Landing accident, autothrottle speed control system, crew overreliance, crew procedures, wind shear.

Synopsis

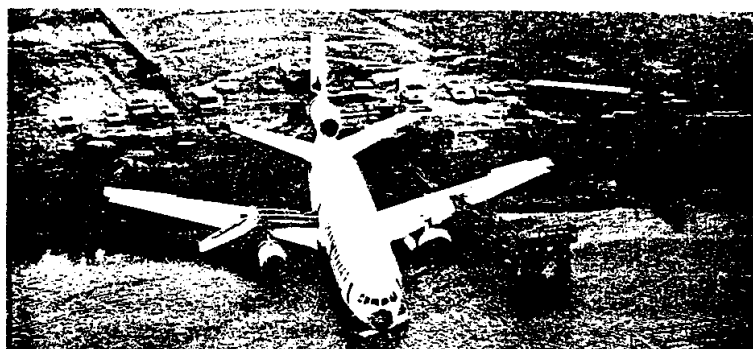
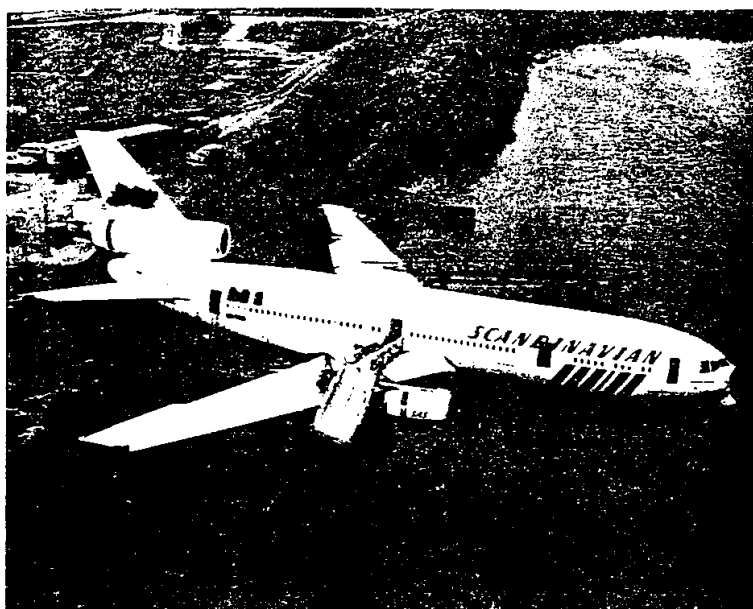
Figure 2.--Flight 901 gt rest in Thurston Basin.

The forward section of the airplane fuselage came to rest in Thurston Basin, a tidal waterway about 600 ft (182.88 meters) from the runway 4R departure end. The airplane was damaged substantially.^(See figure 2.) The captain immediately began to execute the memory items of the "On-Ground Emergency Check List." However, neither he nor the systems operator could move the engine fire selectors or fuel cutoff levers to their full off positions.

The approach light structure for runway 22R was damaged substantially from contact with the left wing.

The aft portion of the fuselage remained generally intact. There was major damage at the lower nose area, to the radome, and to the forward pressure bulkhead at fuselage station (FS) 275. The nose landing gear structure had collapsed under the fuselage. The drag braces were fractured and had separated from their attachment fittings. The interior of the forward fuselage area was deformed and exhibited fractures at the flight deck and galley floor locations. Several floor beams below the galley floor were fractured and twisted.
